National Highway
Traffic Safety
Administration

Case Vehicle (A): 1998 Cadillac Type: DeVille, 4-door sedan

Driver: 73-year-old male

CDC: 12-FDEW-2

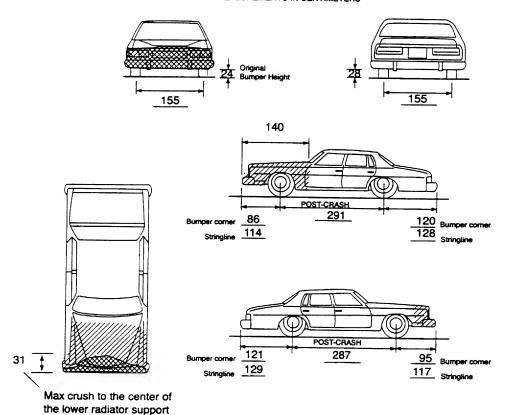
VEHICLE DAMAGE

(Slide 14) Overall damage to case vehicle (A) was moderate. Direct damage to case vehicle (A) was to the entire frontal plane. (Slide 15) The maximum crush was 31 cm to the center of the vehicle front.

Duplicate columns 1-8 M from the previous card.	Module D A Format 0 1 12		DAMAGE DA-2								
MAXIMUM SHEET METAL CRUSH											
	(cm) (999) UNKNOWN										
FRONT	<u>0</u> 3 <u>1</u>	RIGHT SIDE	0 0 0								
REAR	19 0 0	LEFT SIDE	<u>O</u> <u>O</u> <u>O</u> <u>24</u>								
ROOF	<u>O</u> <u>O</u> <u>O</u> <u>O</u> <u>27</u>	OTHER	<u>Q</u> <u>O</u> <u>O</u> <u>30</u>								
CHRONOLOGICAL SEQUENCE OF DAMAGE/INJURY PRODUCING CRASH EVENTS FOR CASE VEHICLE											
NOTE: IF CHRONO IS UNKNOW ORDER IS C		DO YOU KNOW THIS TO BE IN CHRONOL (0) NO (1) YES	S TABLE LOGICAL ORDER? 1								
EVENT NUMBER -	IMPACT LOCATION (1) ON ROADWAY (2) SHOULDER/MEDIAN/GORE (3) ON ROADSIDE (4) OUTSIDE ROADSIDE RIGHT-OF-WAY (5) OTHER (6) OFF ROADWAY, LOC. UNK. (9) UNKNOWN	IMPACT CONFIGURATION FOR CODES, SEE TABLE ON PAGE DA-3.	OBJECT/VEHICLE CONTACTED FOR CODES, SEE TABLE ON PAGE DA-4.

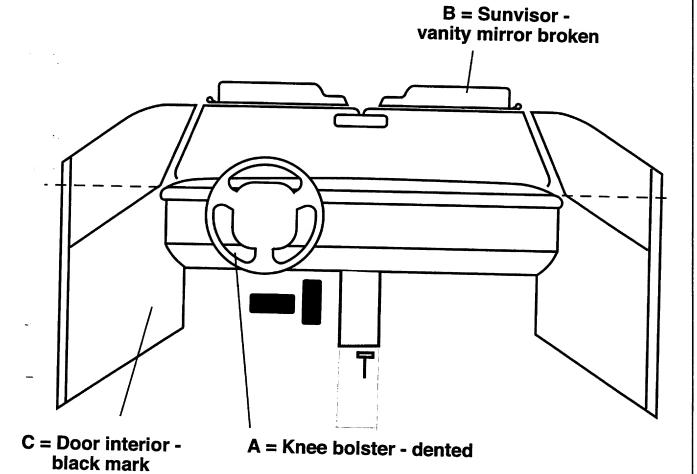
VEHICLE OCCUPANT CONTACT DIAGRAM

Confidence
	Interior	Occupant	Body		Level of
	Component	No. if	Region		Contact
Contact	Contacted	Known	if Known	Supporting Physical Evidence	Point
A	Knee bolster	DR	Lt. leg	dent	1
В	Sunvisor	RF	hand	vanity mirror broken	2
С	Lt. door	DR	Rt. leg	black mark	3
	panel				
D					
E					
F					
G					
Н					
J					
. K
